TECHNICAL REPORT HL-83-15

DESIGN FOR PREVENTION OF BEACH EROSION AT PRESQUE ISLE BEACHES, ERIE, PENNSYLVANIA

Hydraulic Model Investigation

William C. Seabergh

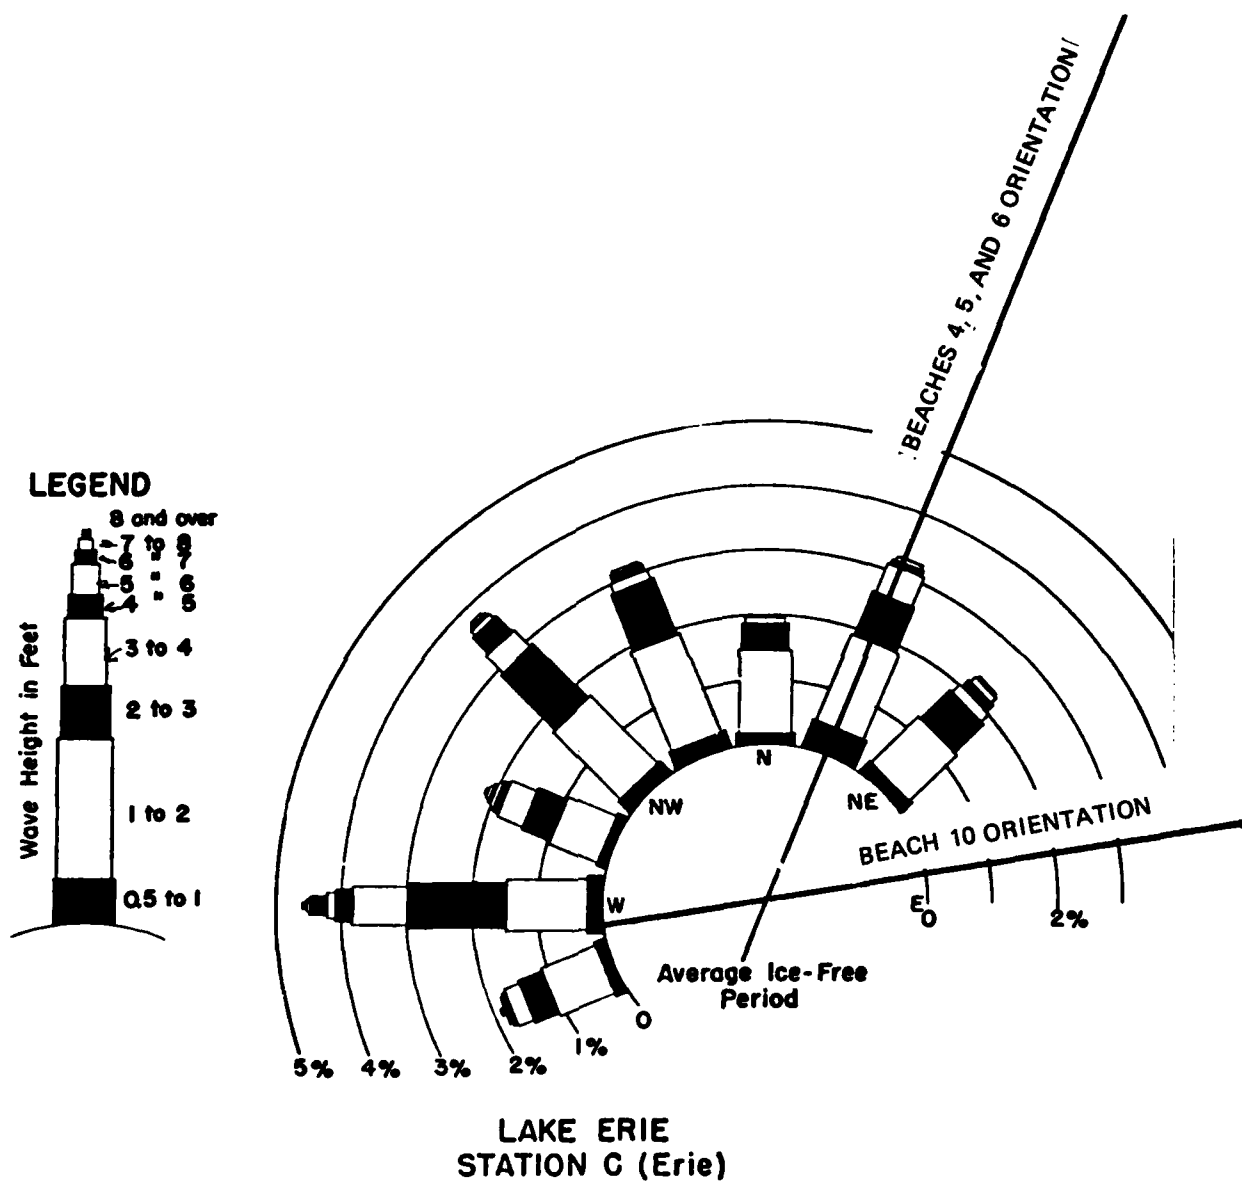
Figure 6. Wave rose showing percent of time waves of different height occur from each direction (Saville 1953)

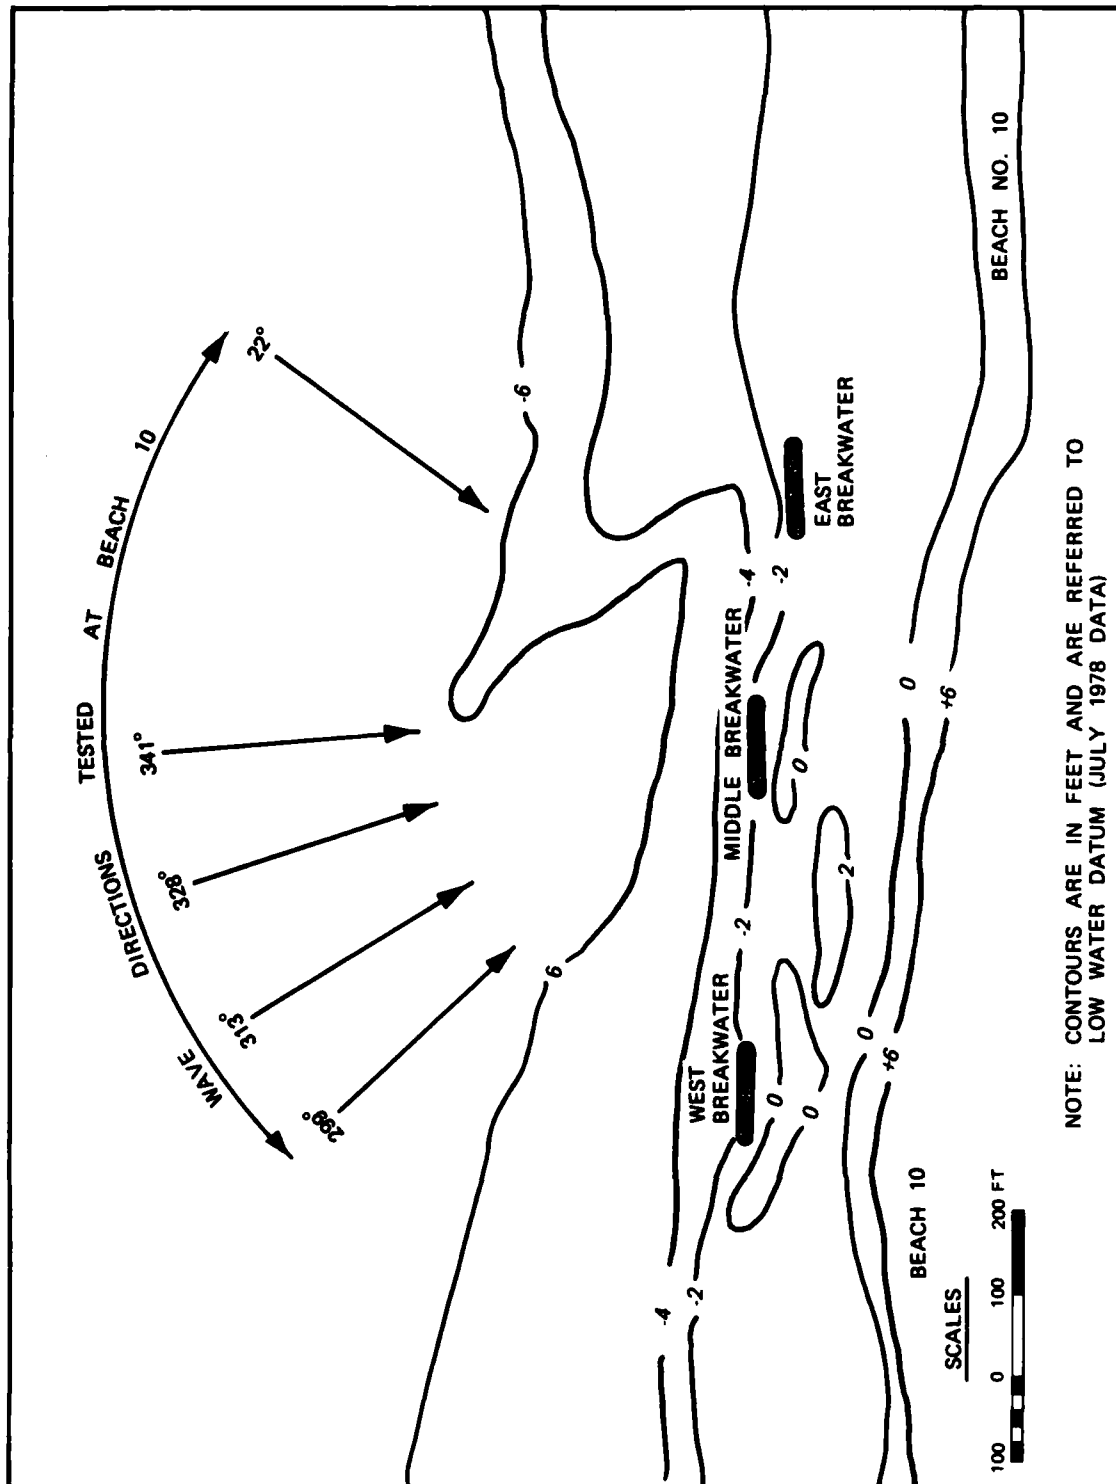
Figure 14. Wave directions tested at Beach 10

34. Test 15. The wave angle was flattened to 328 deg (see Figure 14). Plates 49-51 show that this test produced similar results to Test 14, with strong growth behind the central breakwater. At this time, a check of crest elevations of the breakwaters was made and it was noted that the crest of the west and east breakwaters had degraded slightly in the course of work on molding and remolding the movable bed between tests. The crowns were built up to the correct elevation and a test similar to Test 15 was run.

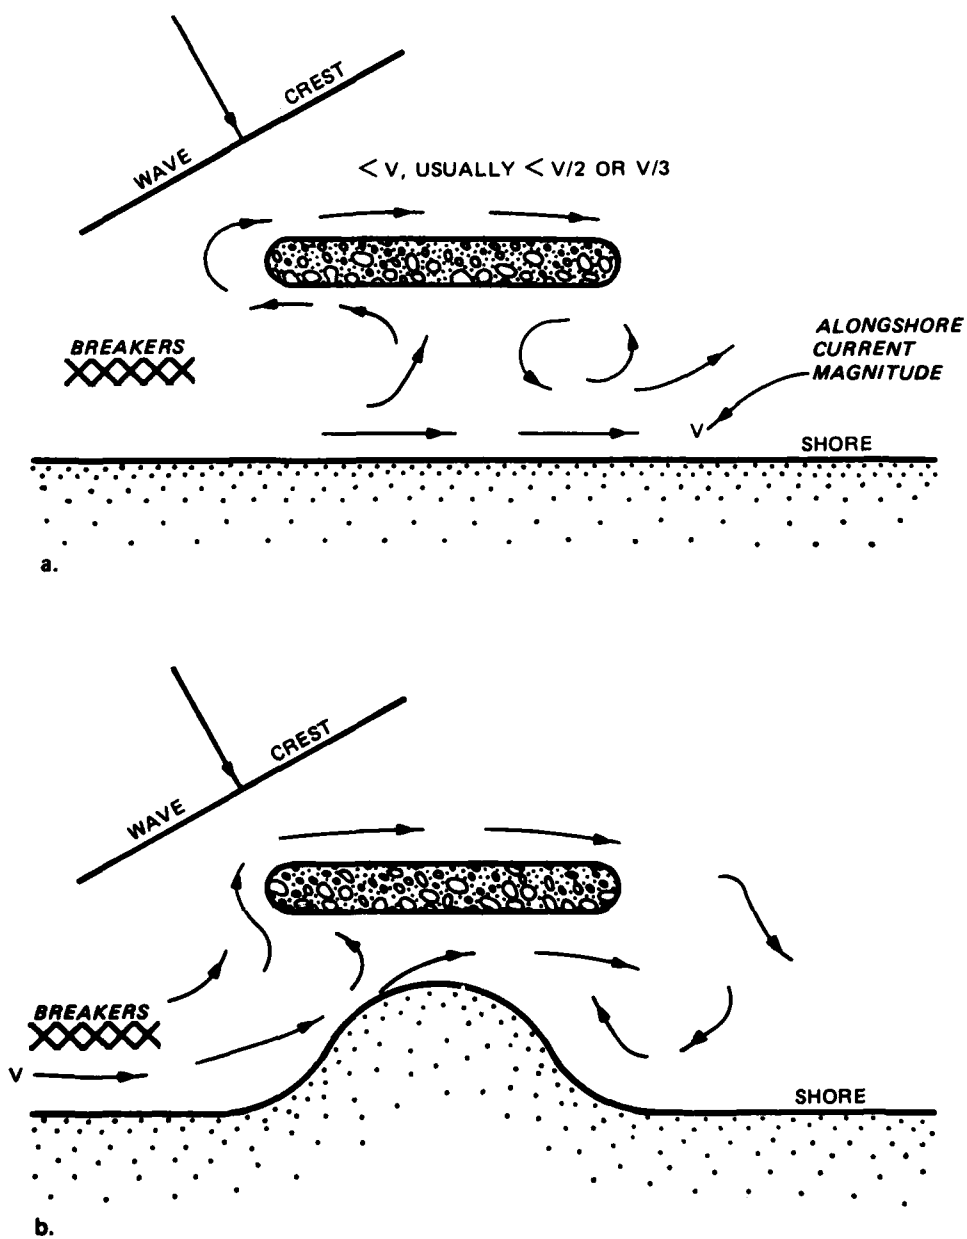
Figure 22. General model of currents in the vicinity of an offshore breakwater

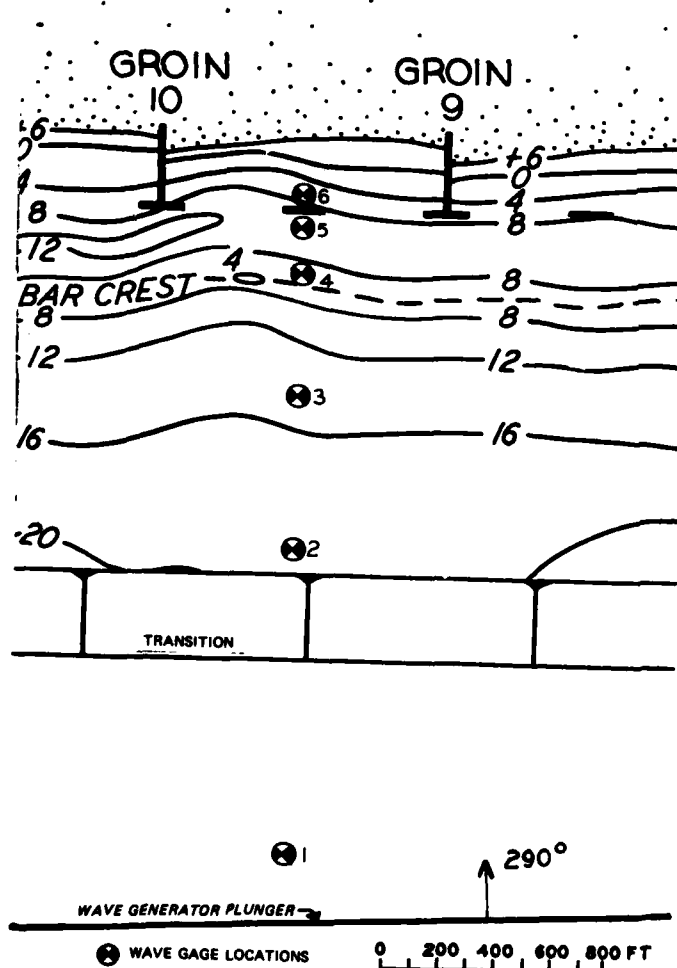
Figure 24. Wave gage locations

102. Wave measurements were made for the design wave condition (12.8-ft, 9-sec, +6.9 ft water level) at gages positioned as shown in Figure 24. As

noted in Figure 24, the breakwater was at the -10 ft contour, the depth of the Plan 1 breakwater. A second test condition was set up and run with the breakwater located at the -5 ft contour, the depth of the breakwater outside the groin field. Table 4 shows the wave-height measurements. Three runs were made for each breakwater location at different wave generator stroke settings to bracket the design wave height. The data then were averaged for each breakwater location. Gage 5 was located at the sea-side toe of the breakwater; gage 6 was located at the toe of the breakwater on the shoreward side. The wave height was reduced by about one-half by the breakwater for this overtopping condition. The
